# Offering an all-in-one solution

When dealing with small-diameter drinking-water pipe inspections, not many technologies exist that offer full-condition assessment capabilities without interrupting water service

In November 2013, GAME Trenchless Consultants was contracted by the Ontario Clean Water Agency (OCWA) Engineering Services, with the Municipality of Southwest Middlesex in the community of Glen-coe, to provide a full visual condition assessment and leak-detection survey of the municipal water mains.

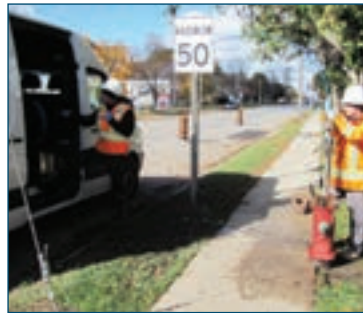
*Crews were able to complete the surveys in less than a week*

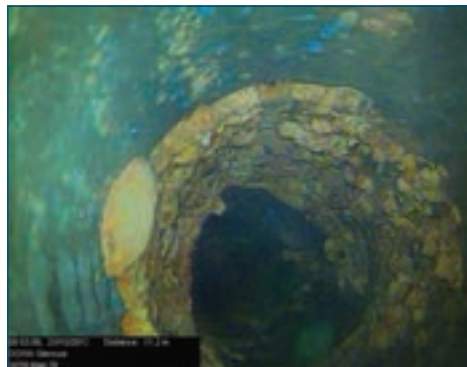
*Below right: initial view – subsequent swabbing had a positive effect on the condition of the pipe, removing a large amount of debris*

Visually, it became evident that swabbing had a positive effect on the condition of the pipe, removing a large percentage of the tuberculation and debris present in the water main. The water-main cleaning also translated to an increase in inspection capacity, given that the limiting factor during an inspection is the condition of the pipe.
