“Investigator+” enables non-disruptive watermain leak detection

JD7 Investigator+ can be launched through fire hydrants, pressure fittings, air valves and gate valves while the mains remain in service

As part of a pilot project with the City of Vancouver, B.C., a quadrant delimited by Prince Edward Street, between 34th and 36th Street, was selected in order to perform an internal pressurized inspection using the JD7 Investigator+ unit.

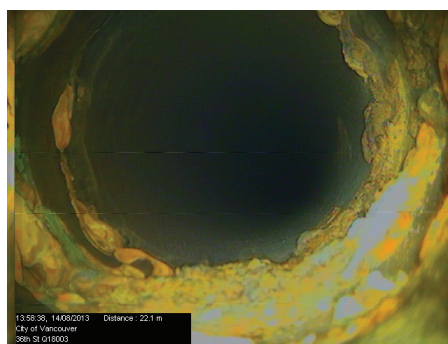
Working through fire hydrants, the JD7 Investigator+ provides high-definition images of the insides of pipelines while simultaneously detecting leaks in the line.

the various watermains, we were able to identify sectors which had been rehabilitated with cement mortar lining as well as others which hadn't been examined yet. The cast iron lines which had been lined showed no signs of tuberculation throughout the pipe other than at the tees and various bends or valves. The cast iron lines which were approximately of the same pe-

riod, without having undergone rehabilitation, were now showing signs of anywhere between 5 to 20 percent reduction due to tuberculation. Despite encountering some areas with heavy tuberculation, no acoustic points of reference or anything that may have been perceived as a leak were detected. The nine access points which were utilized allowed us to cover over 300 metres of watermain in the area.

Having identified zones where tuberculation was becoming an issue, the City now possessed the documentation validating the actual condition of the watermains in that area. As a result of the work performed, the unlined mains have been identified as rehabilitation candidates in the near future.
